Manhole Inspection Summary

Manhole # S51M__018MH

Insp Date: **7/24/08 3:26 PM**

Location Address: **817 fait hudson alley**

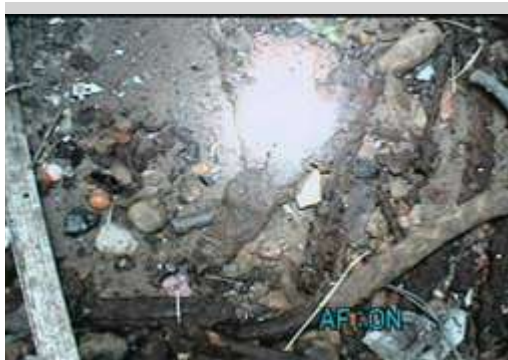
Defect 1

Condition: ☐ Sound ☐ Cracked ☐ Root Intrusion ☐ Deteriorated ☐ Leaks ☒ **Debris**

channel debris

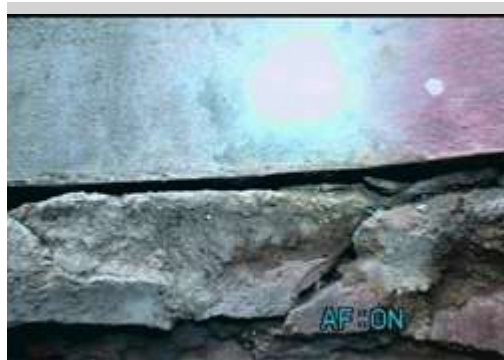
Defect 2

Condition: ☐ Sound ☒ **Cracked** ☐ Root Intrusion ☐ Loose Brick ☒ **Deteriorated**

chimney cracked and deteriorated, frame adjustment

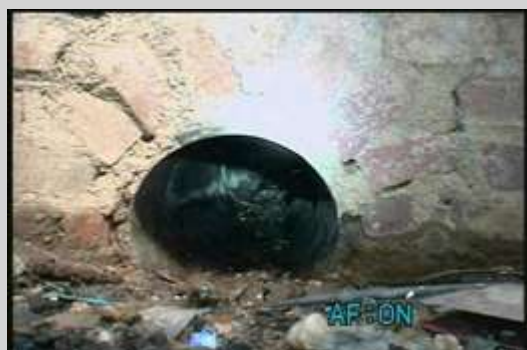
12 O'Clock Outflow

8 in. Circular Gravity Sewer
Pipe Out @ 12 O'Clock

Deposits: ☒ None ☐ Mud ☐ Sludge ☐ Debris ☐ Grease

Infiltration: **None** Pipe Seal Cond: **Unknown**
